FLIGHT MEASUREMENTS OF THE FLYING QUALITIES

OF AN F6F-3 AIRPLANE (BUAER NO. 04776)

II - LATERAL AND DIRECTIONAL STABILITY AND CONTROL

MEMORANDUM REPORT

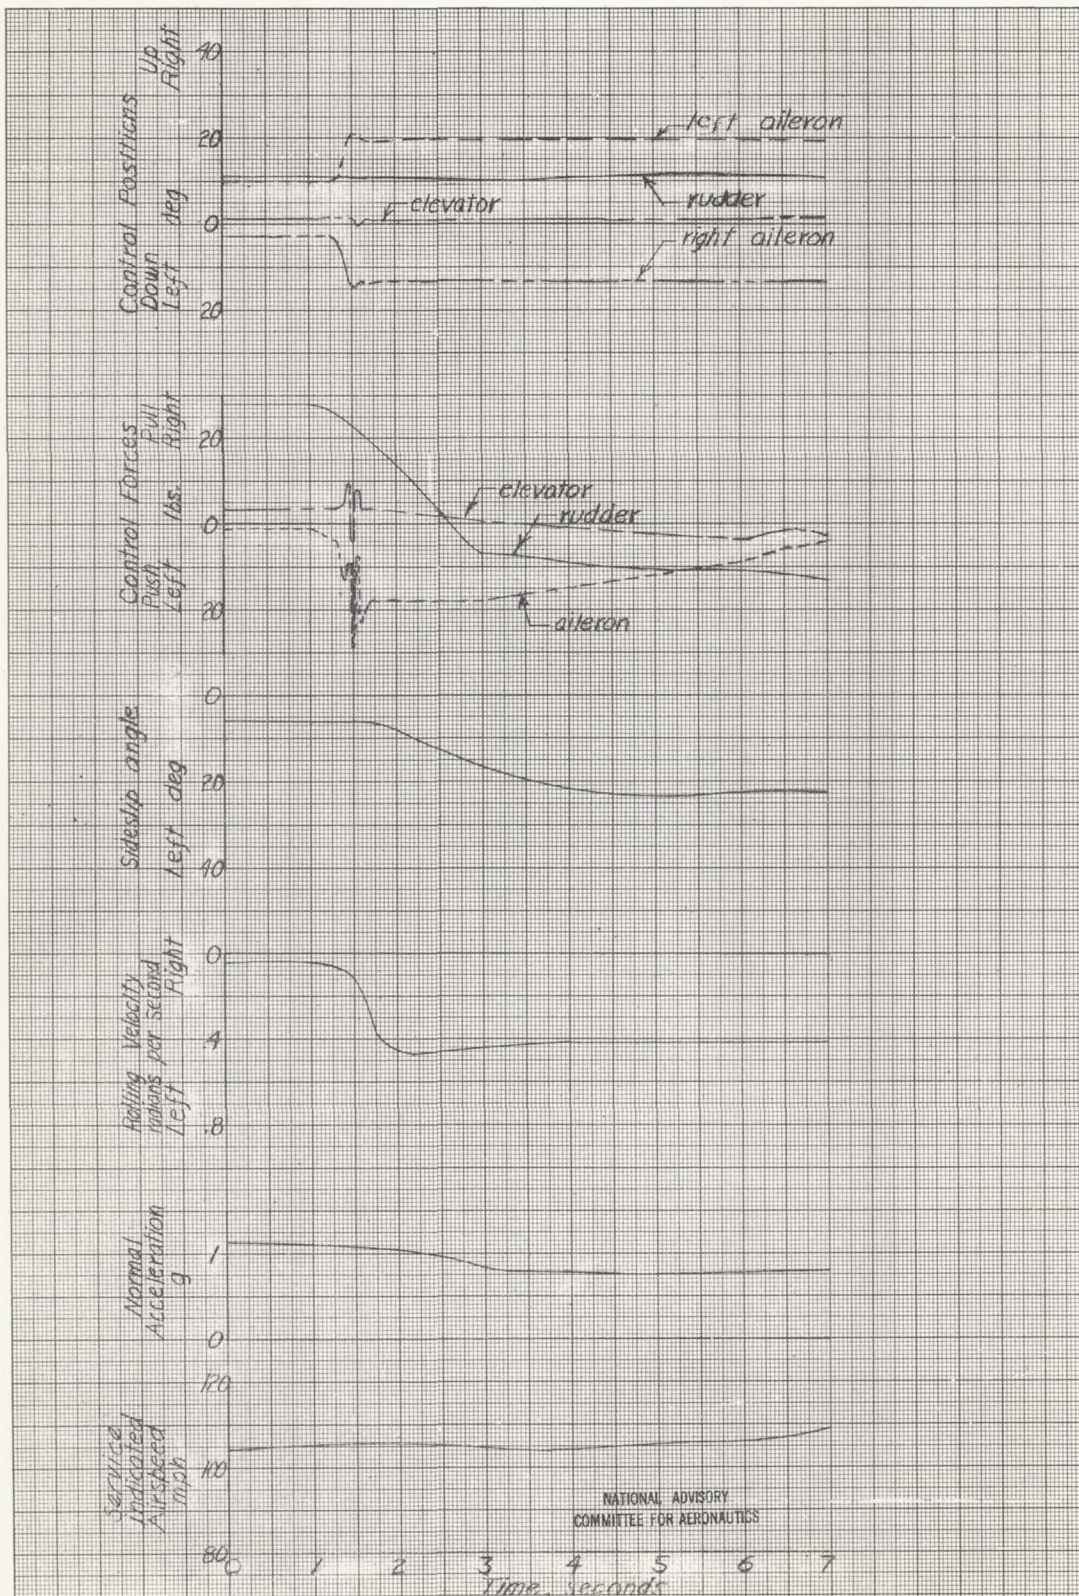
Figure 14. - Time history of rolling out of a right turn using full aileron deflection with rudder held fixed. Clean condition, power for level flight, PoF-3 airplane.

The sideslip due to ailerons was measured in the abrupt aileron rolls from laterally level flight described above and in abrupt rolls out of turns with the rudder held fixed. The latter maneuver has been adopted as standard practice at Langley for measuring sideslip due to ailerons because it has been found difficult to obtain maximum sideslip angle in a roll from laterally level flight, since the airplane usually reaches an extreme angle of bank before maximum sideslip angle is reached. In the present instance, it was possible to reach maximum sideslip angle in right rolls from laterally level flight. Figures 8 and 9 illustrate rolls from laterally level flight. Rolls out of turns are shown in figures 13, 14, and 15. Figure 16 shows the change in maximum sideslip angle as a function of change in total aileron angle in abrupt rolls made from laterally level flight at 98 miles per hour. Inspection of these figures shows that the use of full aileron deflection at approximately 100 miles per hour will result in approximately 18.5° of sideslip.

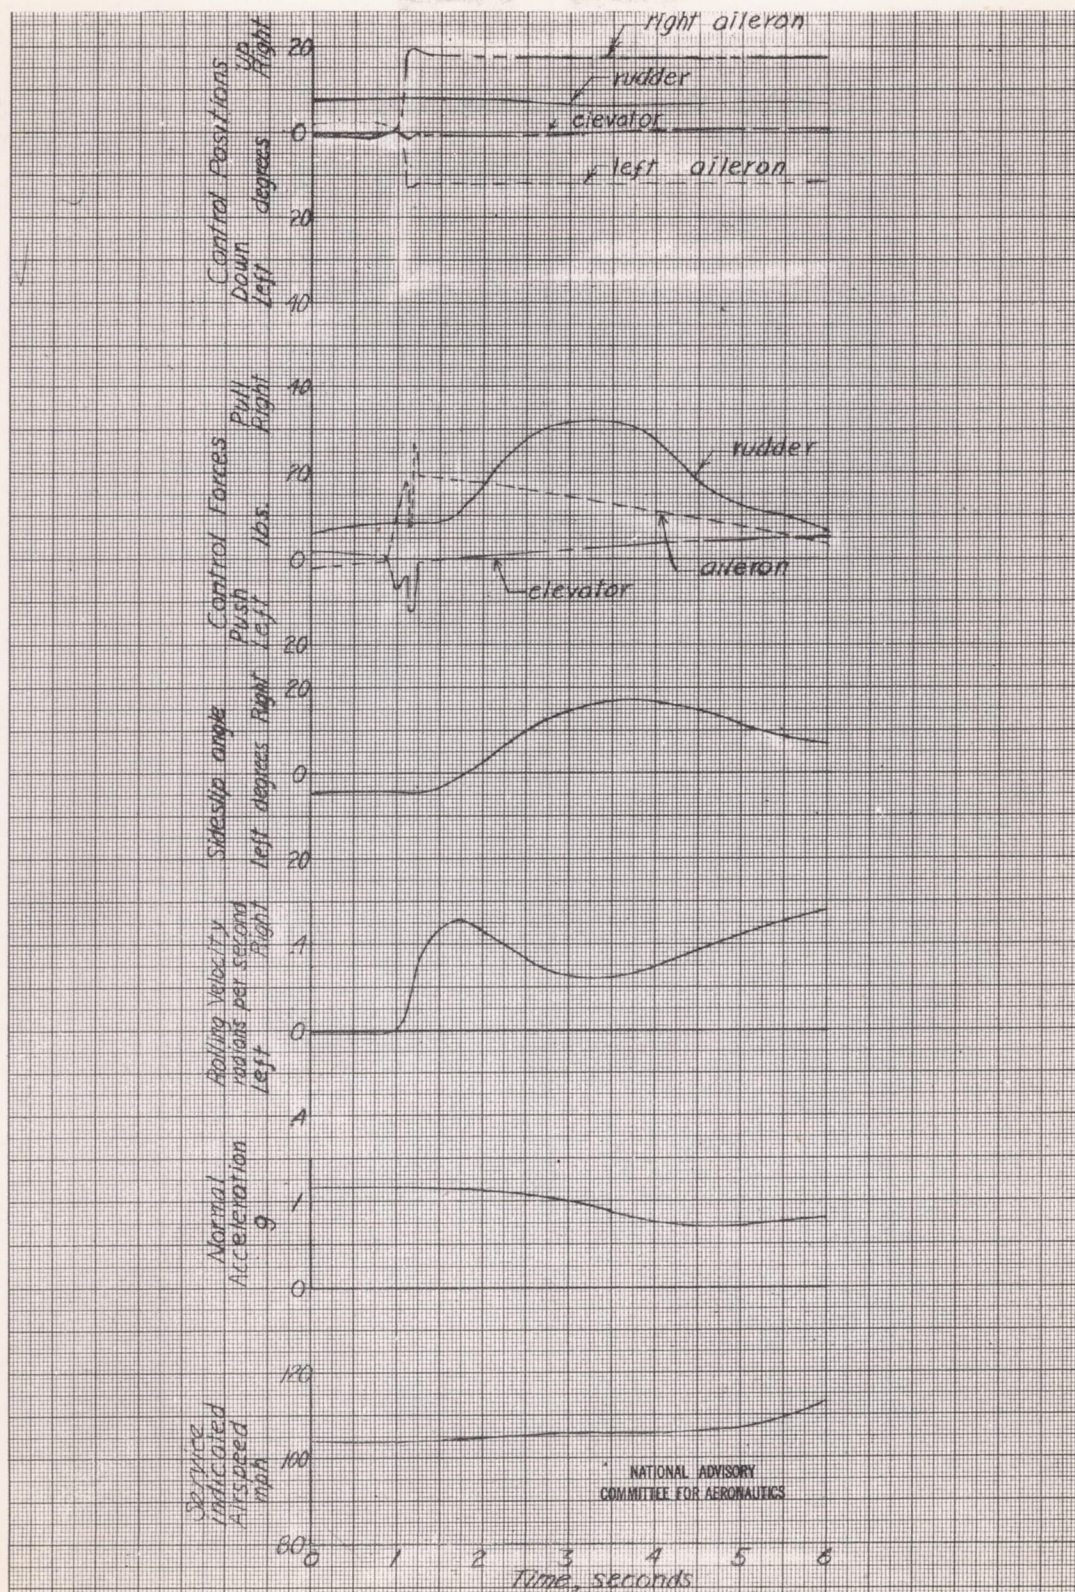
Figure 15. - Time history of rolling out of a left turn using full aileron deflection with rudder held fixed. Clean condition, power for level flight, F-3 airplane.

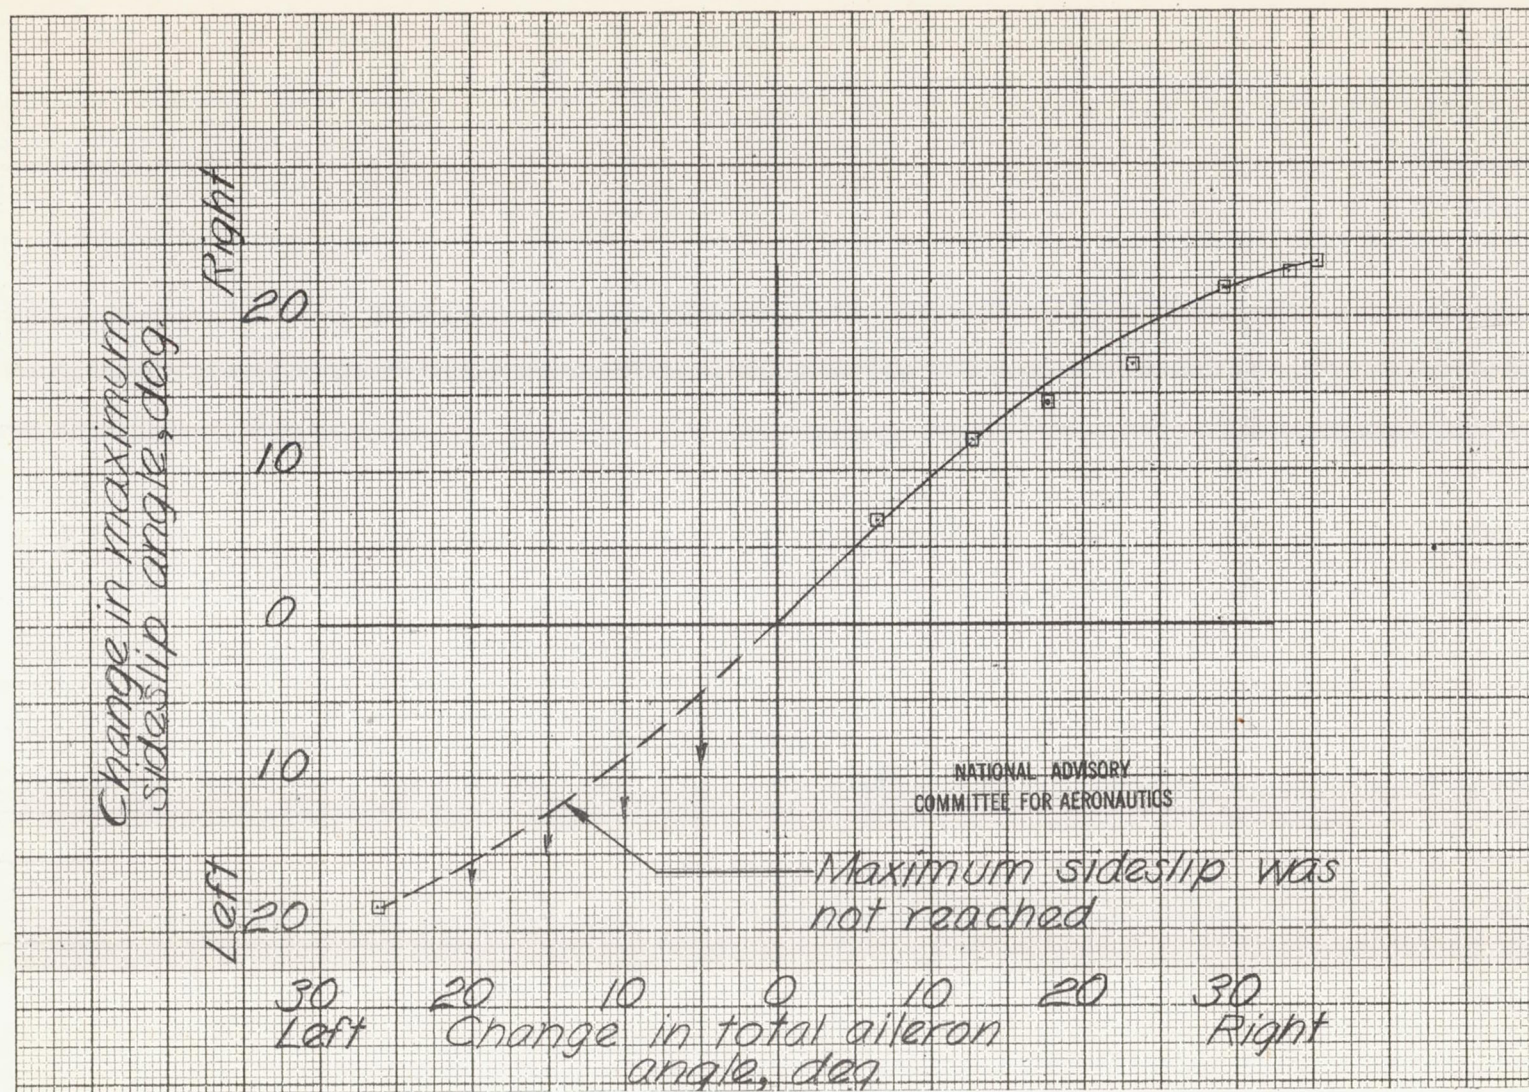
Figure 16. - Change in maximum sideslip angle with change in total aileron angle in abrupt aileron rolls made from laterally level flight at 98 miles per hour. Clean condition, power for level flight, F6F-3 airplane.

4. As shown by figures 16 to 29 right-rudder force was required to hold right-rudder deflections and left-rudder force was required to hold left-rudder deflections.

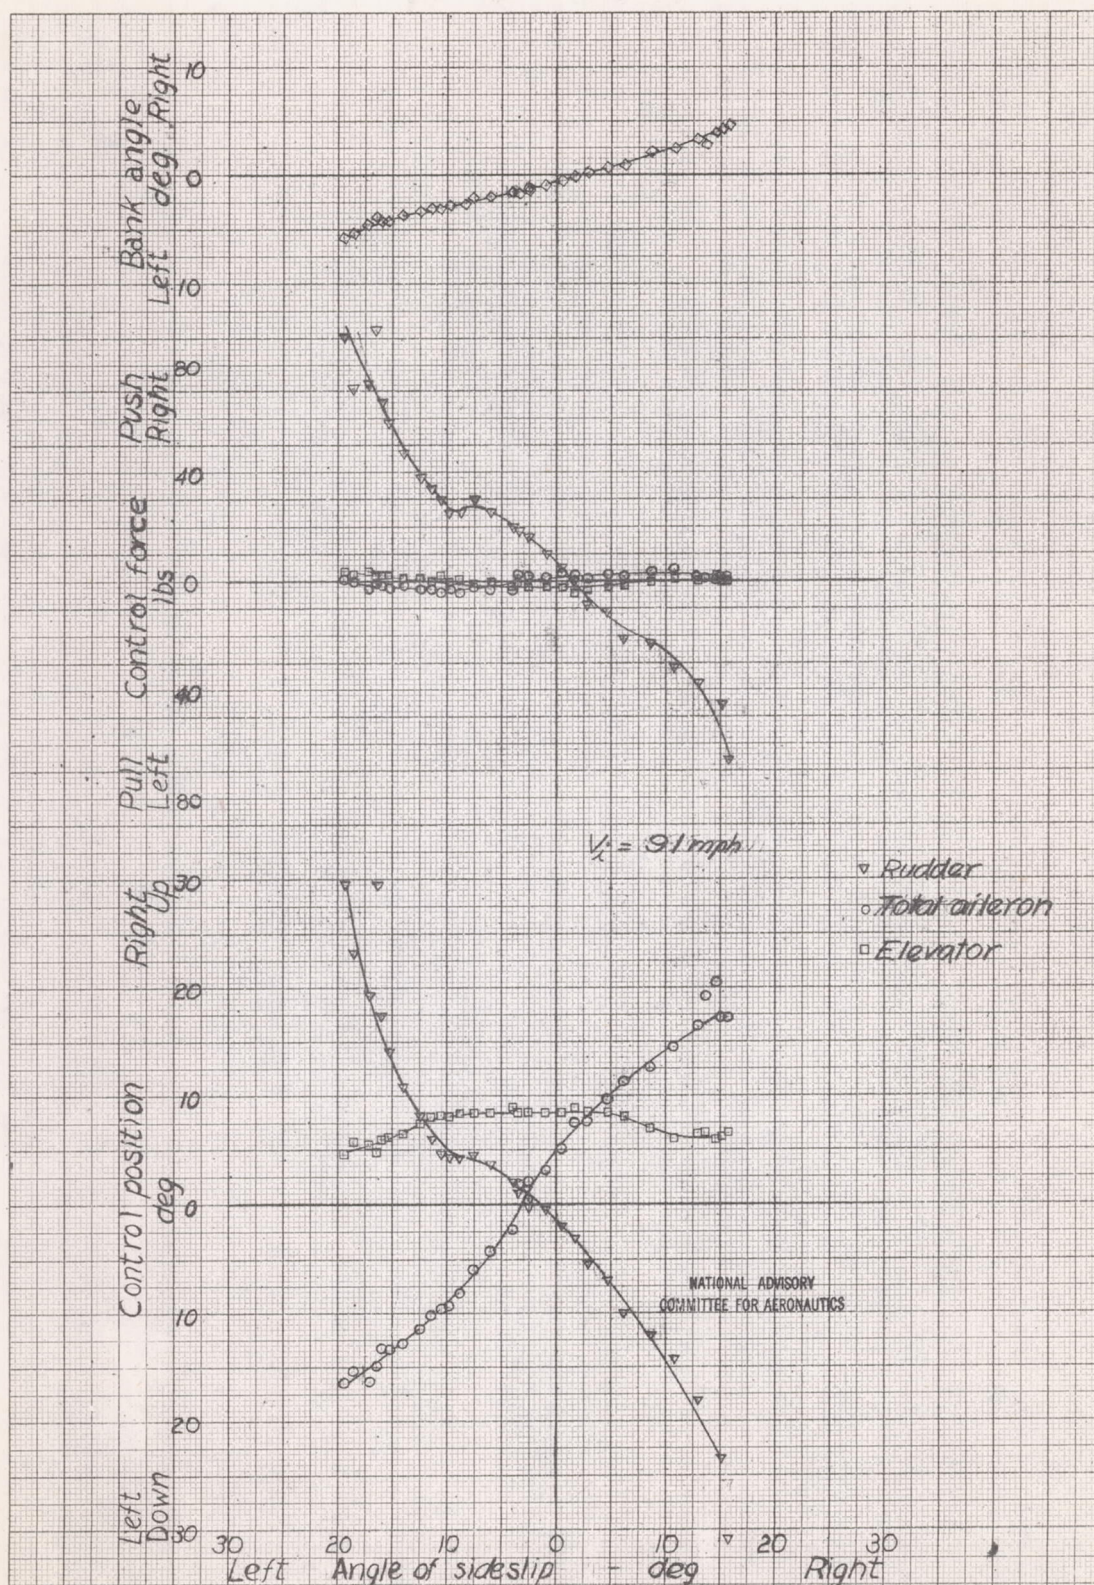
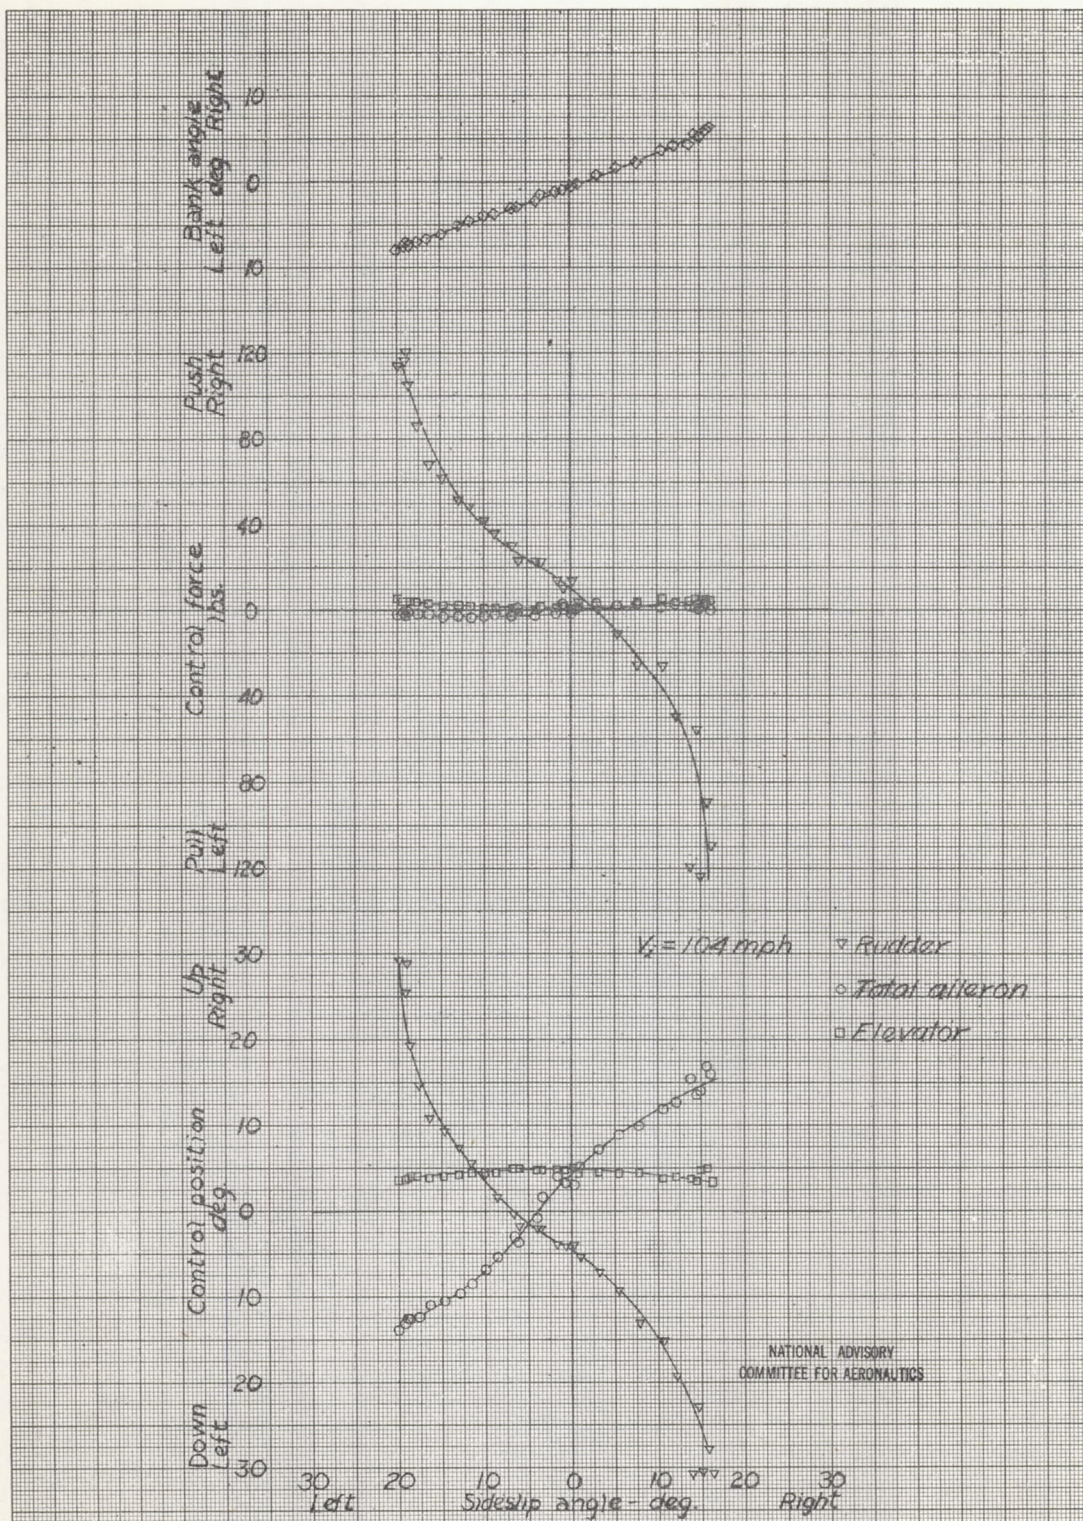
Figure 17. - Steady sideslip characteristics in the landing condition at 91 miles per hour, F6F-3 airplane.

Figure 18. - Steady sideslip characteristics in the landing condition at 104 miles per hour, F6F-3 airplane.

The variation of cross-wind force with sideslip angle was in the correct direction; that is, right bank accompanied right sideslip and left bank accompanied left sideslip as shown by figures 17 to 30.

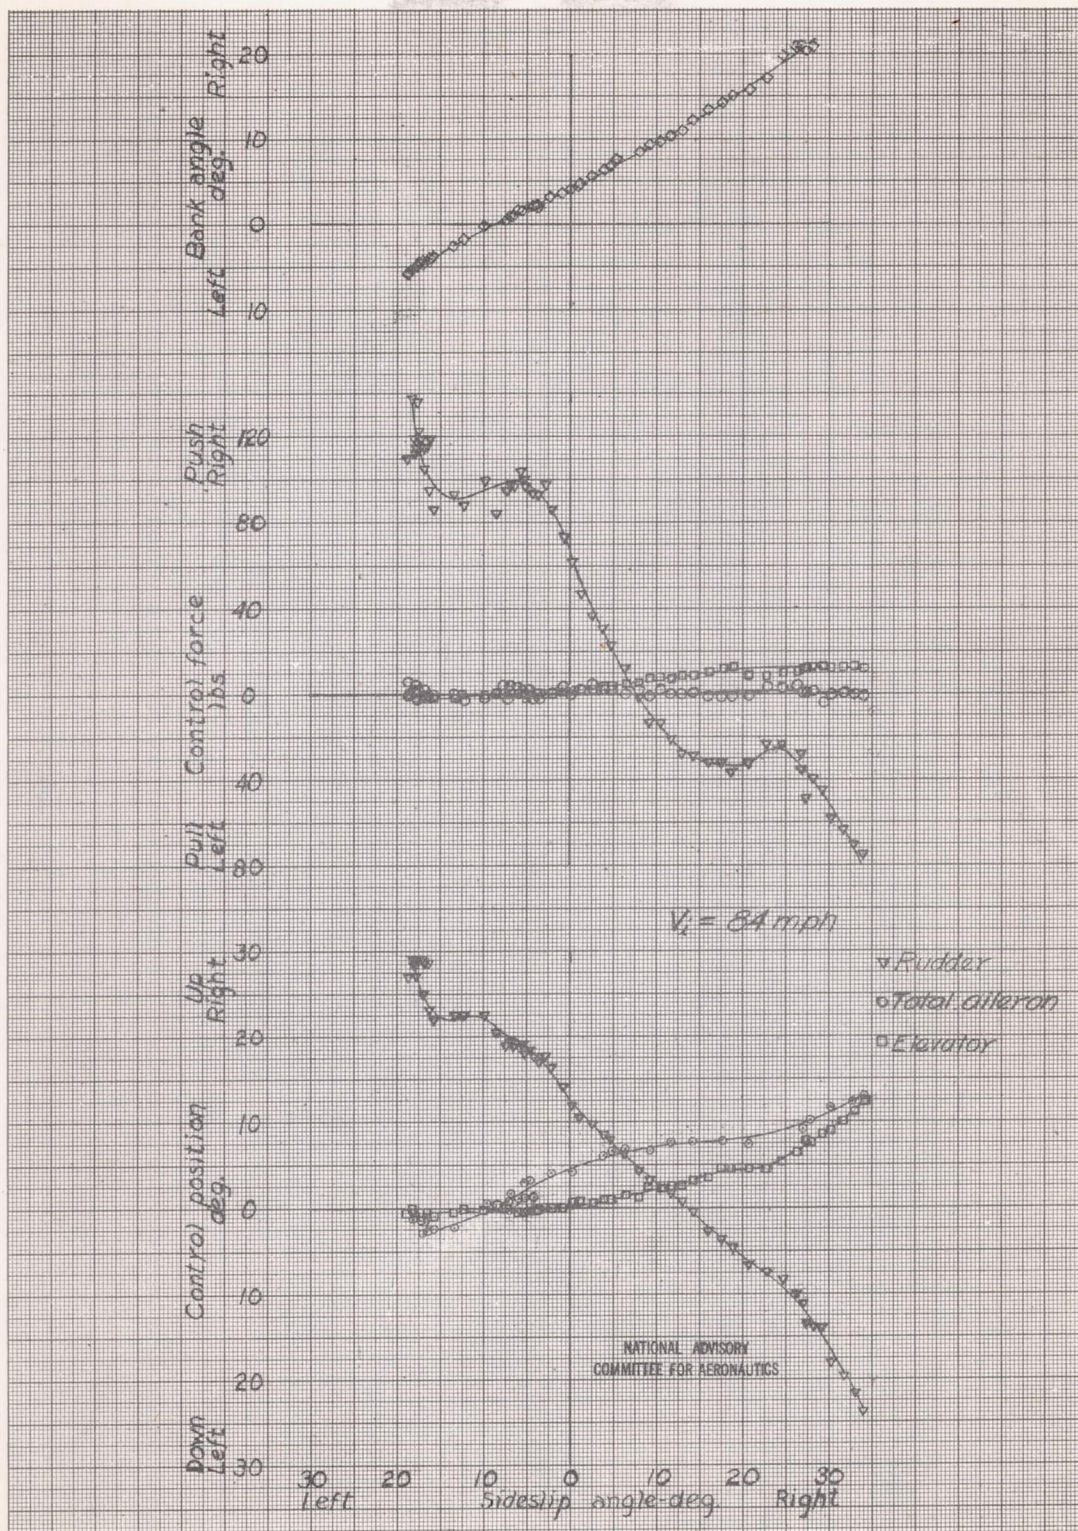
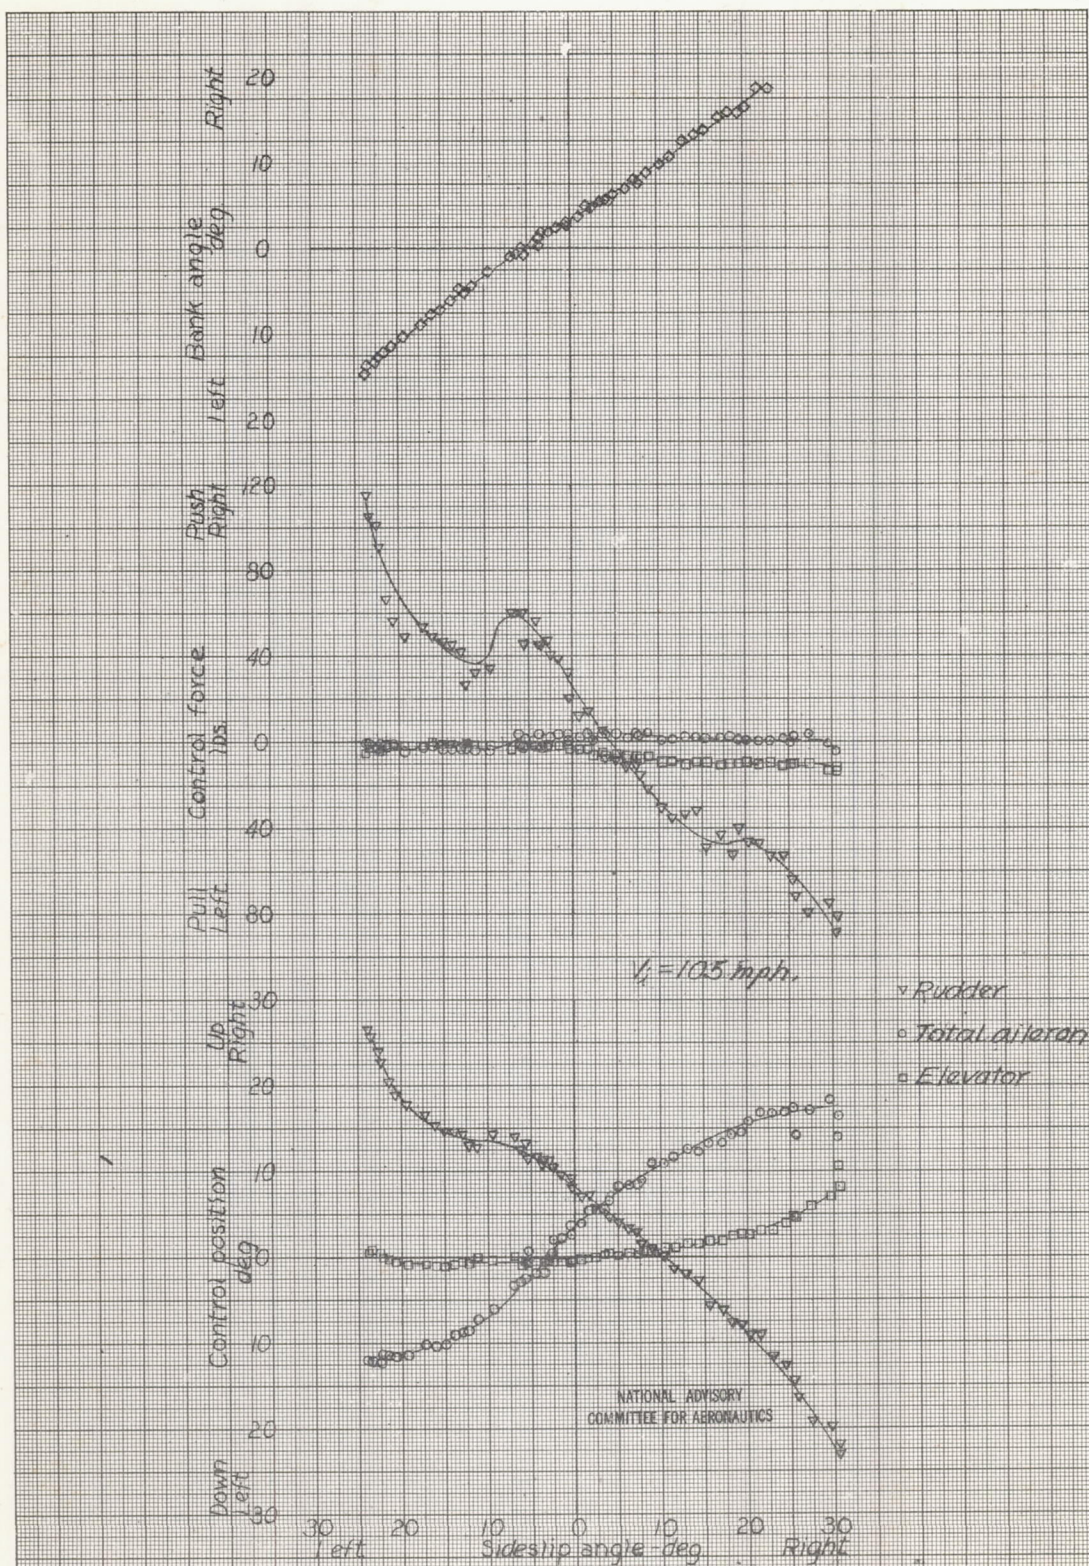
Figure 19. - Steady sideslip characteristics in the wave-off condition at 84 miles per hour, F6F-3 airplane.

Figure 20. - Steady sideslip characteristics in the wave-off condition at 105 miles per hour, F6F-3 airplane.

3. The yawing moment due to sideslip (rudder free) was found to be such that the airplane would always tend to return to zero sideslip, regardless of the angle of sideslip to which it was forced in all conditions of flight tested. In the wave-off condition, however, there was reversal in the slope of the rudder force curves as can be seen by inspection of figures 19 and 20.

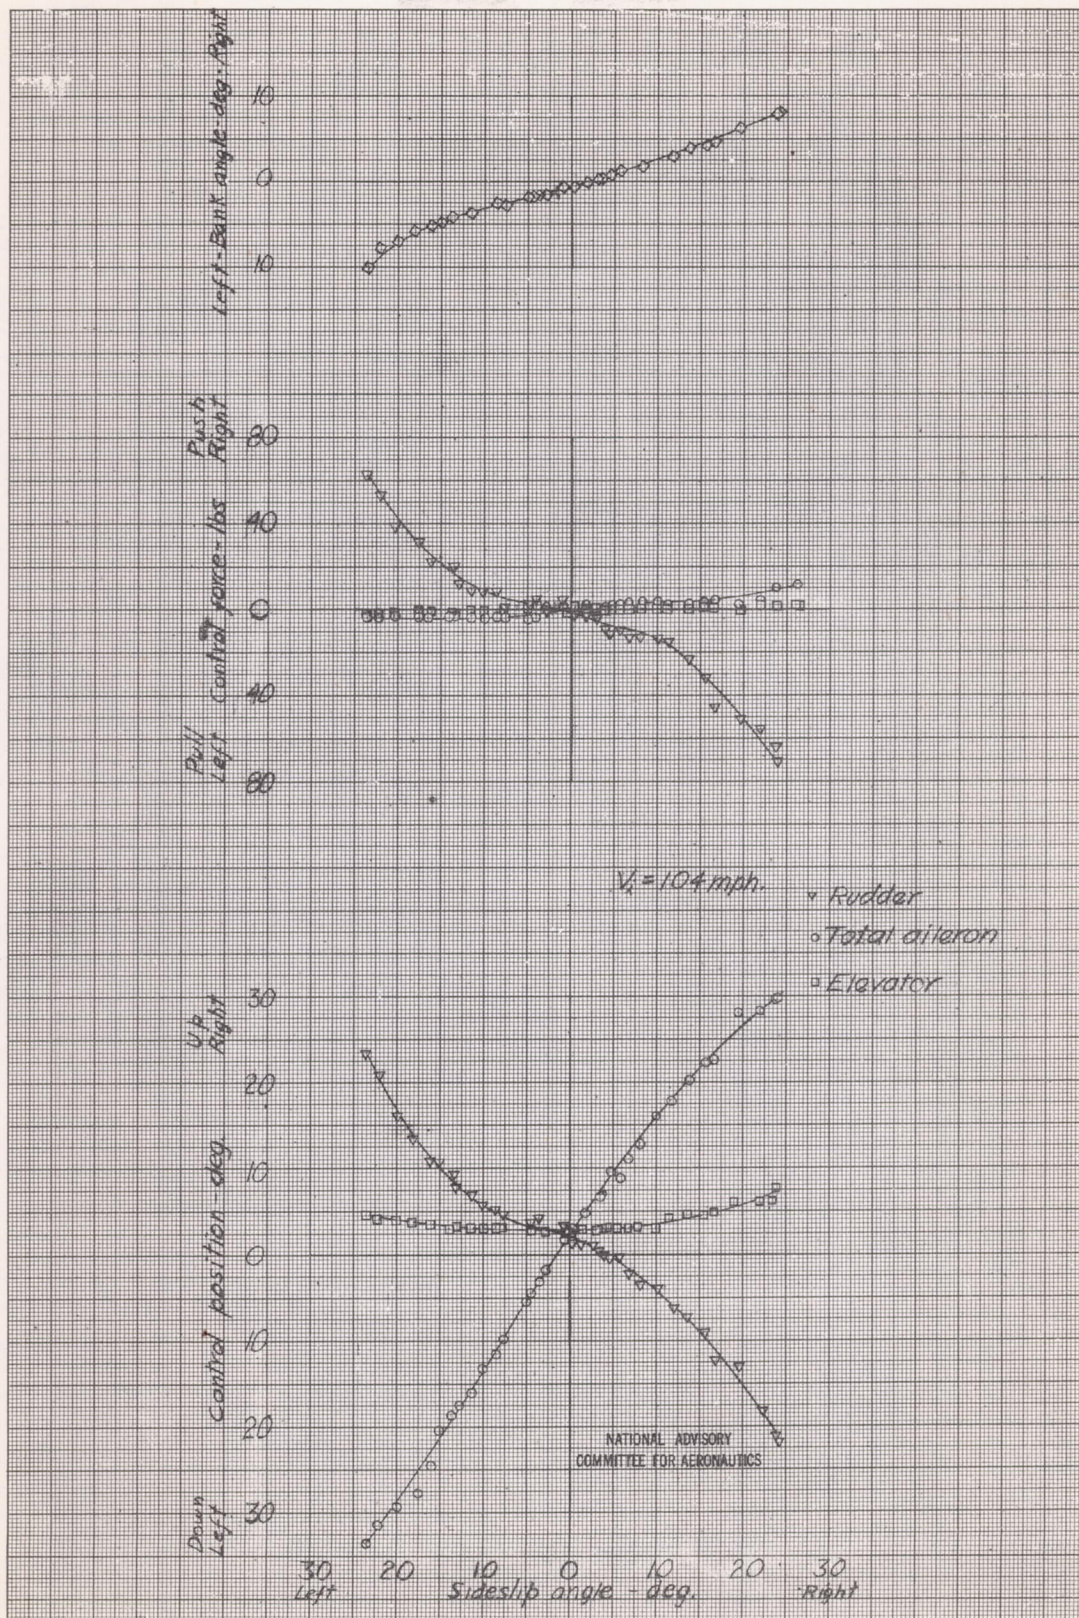
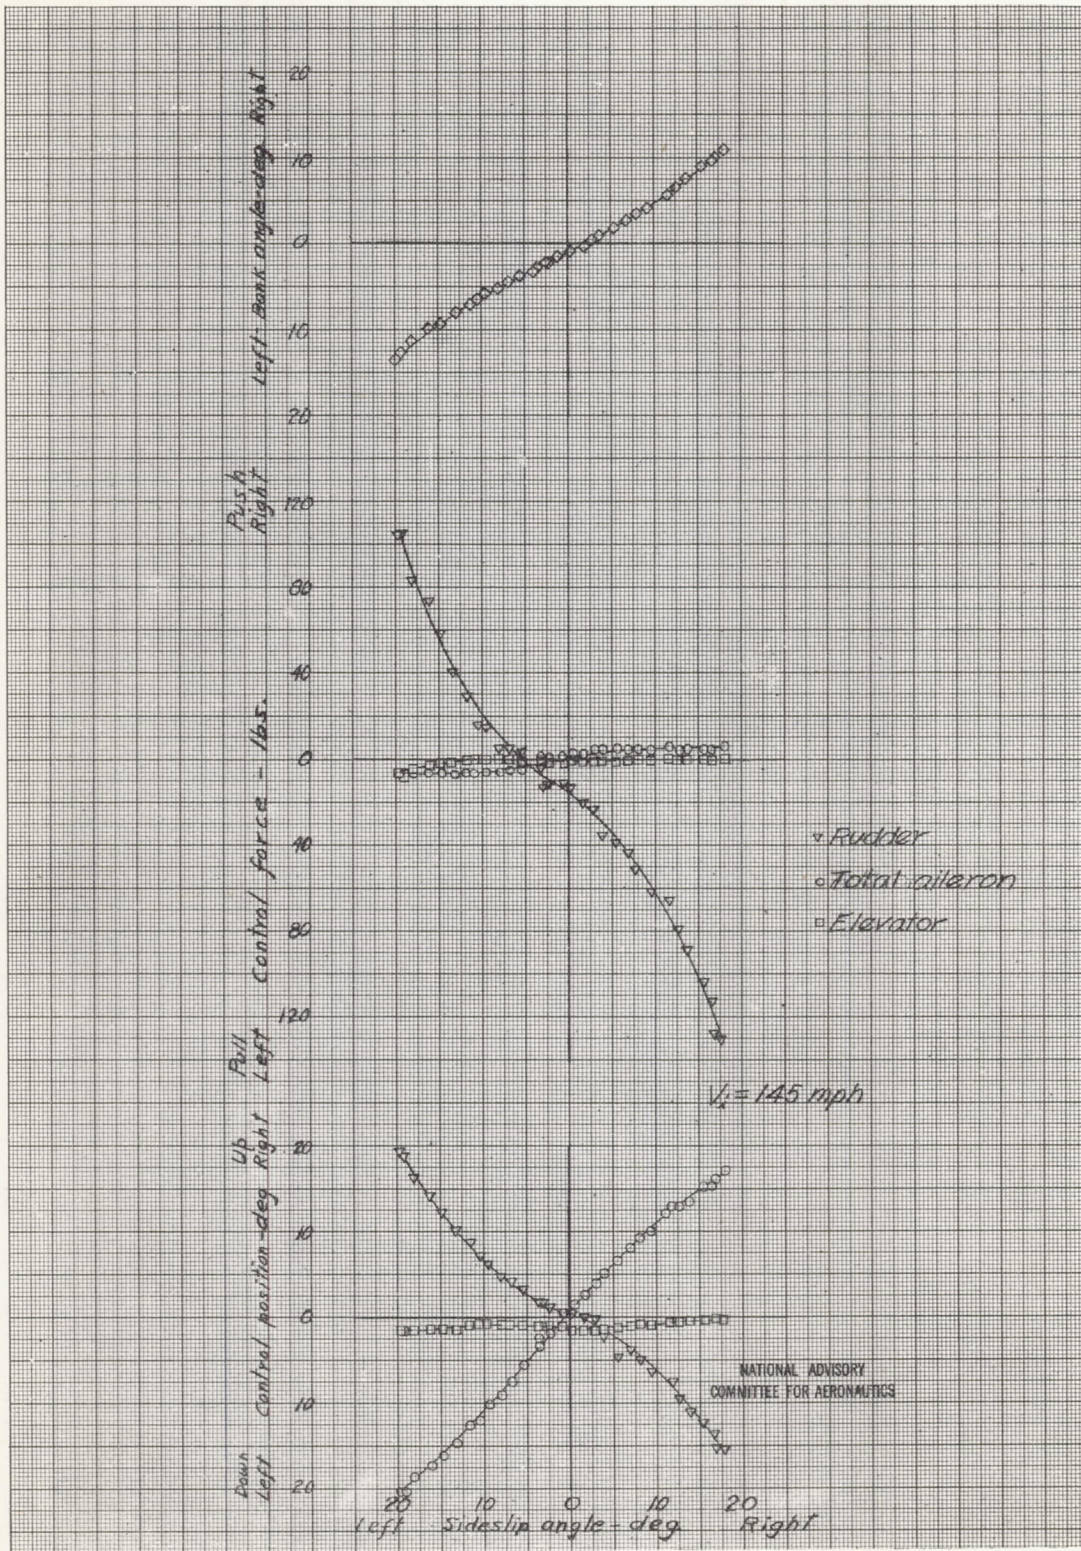
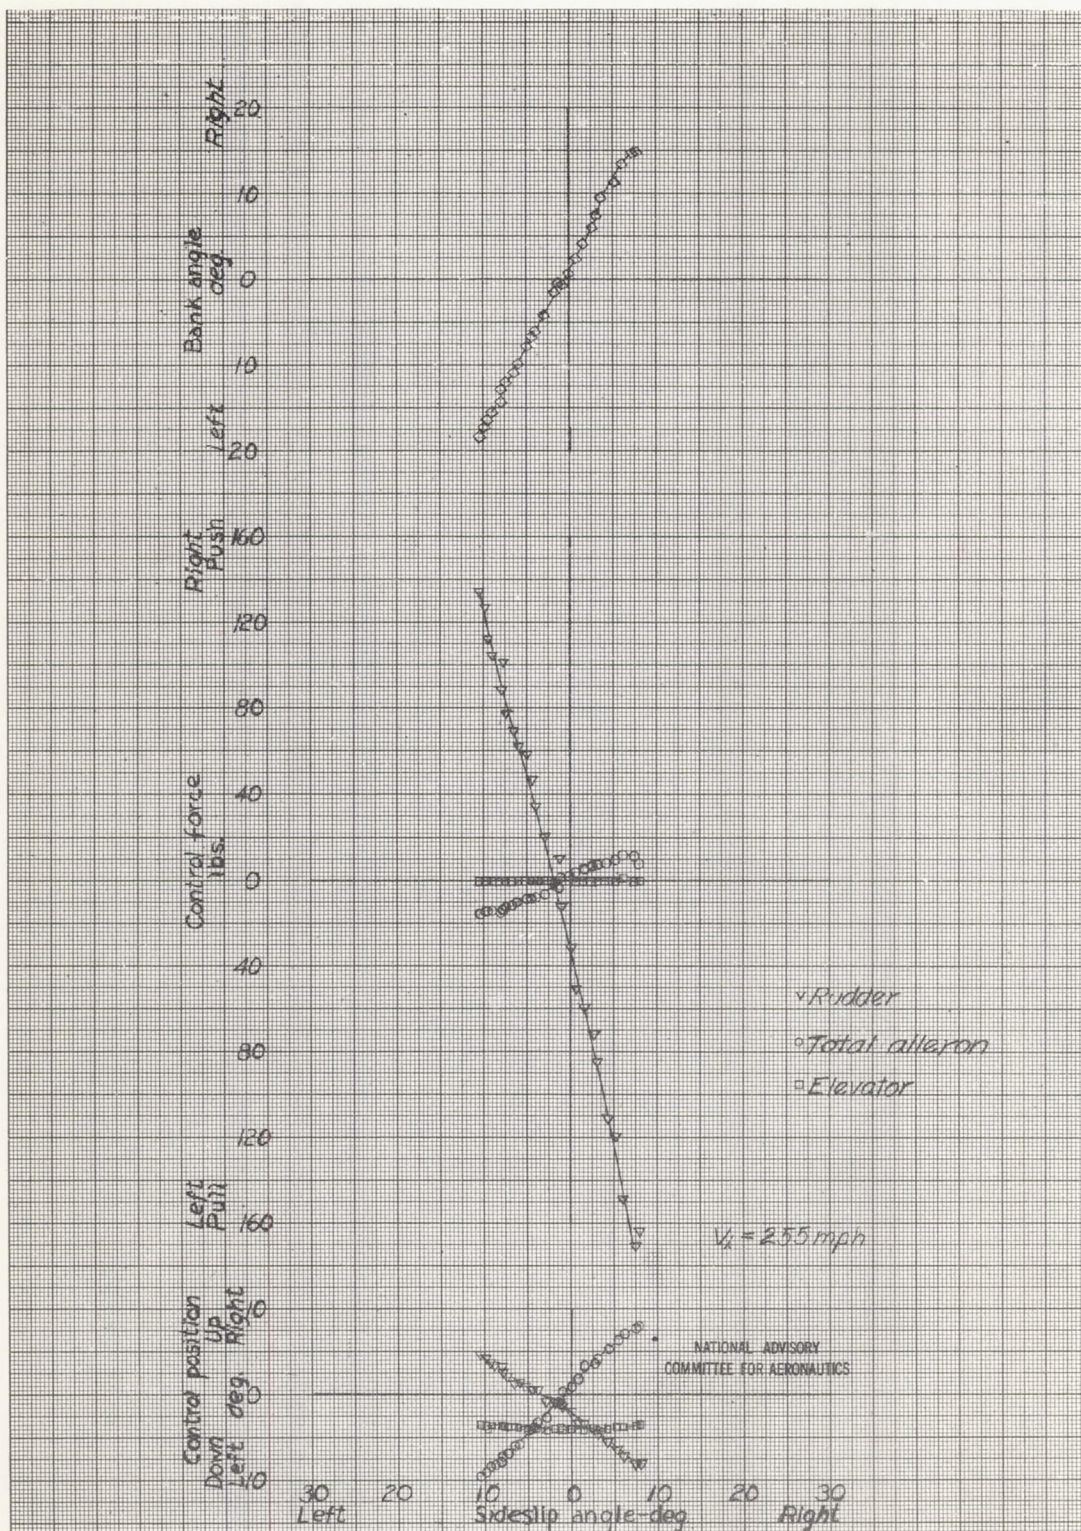
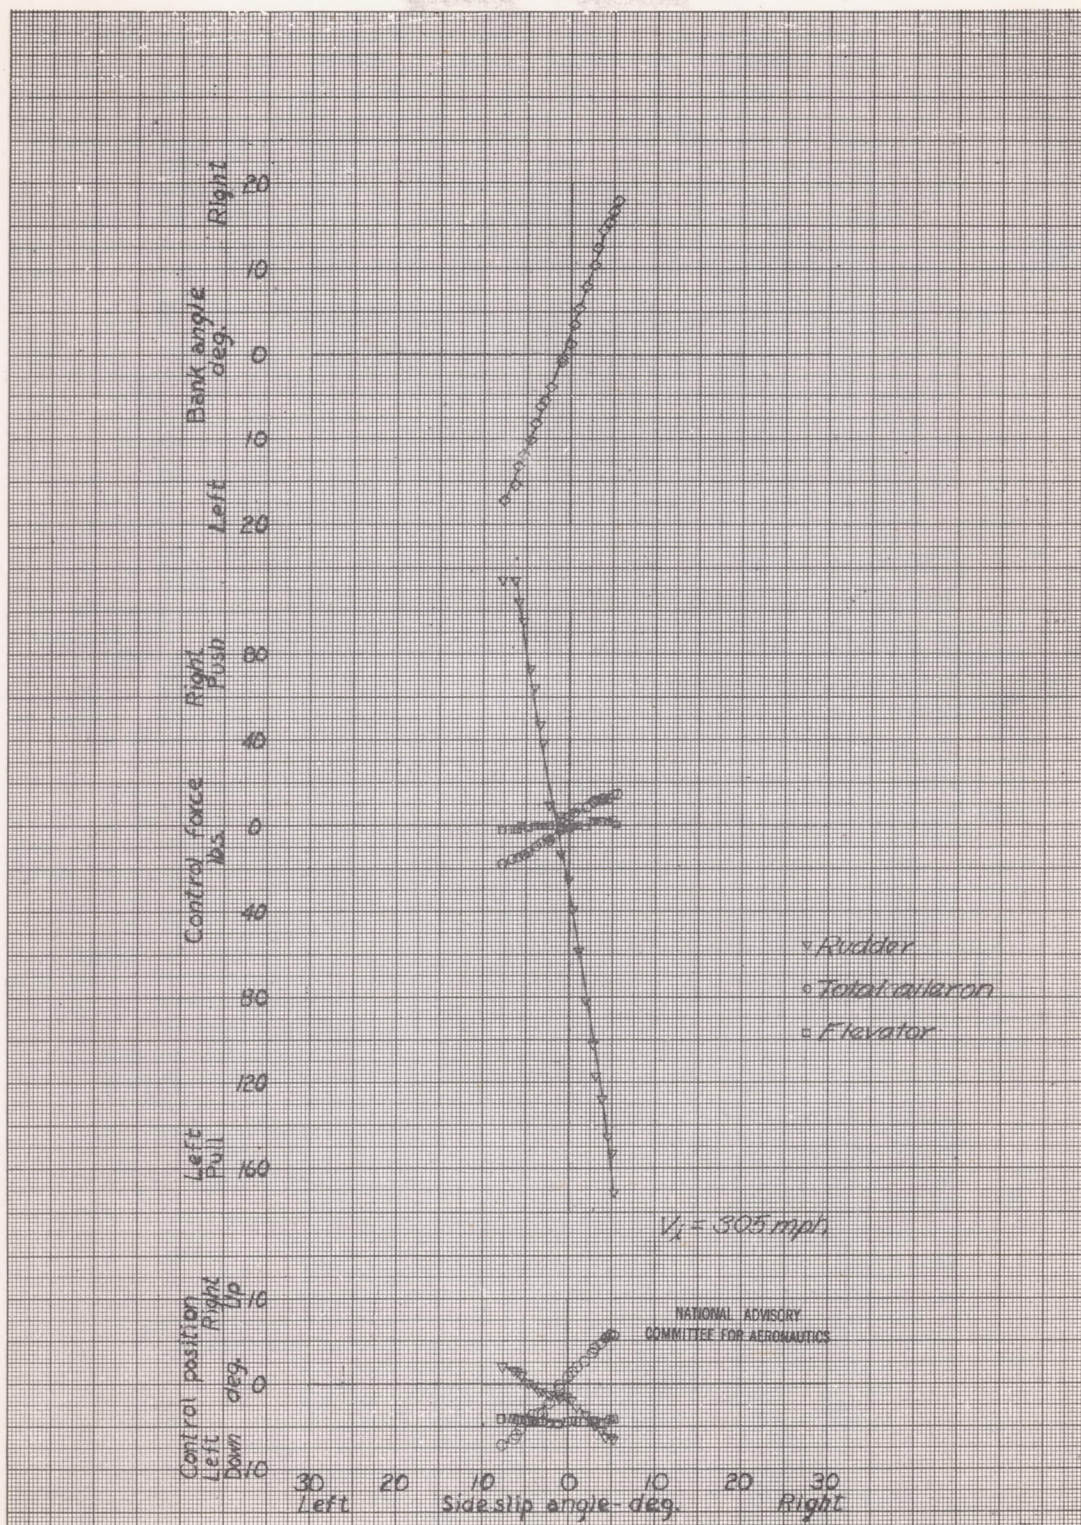
Figure 21. - Steady sideslip characteristics in the gliding condition at 104 miles per hour, F6F-3 airplane.

Figure 22. - Steady sideslip characteristics in the gliding condition at 145 miles per hour, F6F-3 airplane.

Figure 24. - Steady sideslip characteristics in the gliding condition at 255 miles per hour, F6F-3 airplane.

Figure 25. - Steady sideslip characteristics in the gliding condition at 305 miles per hour, F6F-3 airplane.
